Urban fabric, construction types and the art of city-building.

Approaches and methods for post-earthquake reconstruction plans.

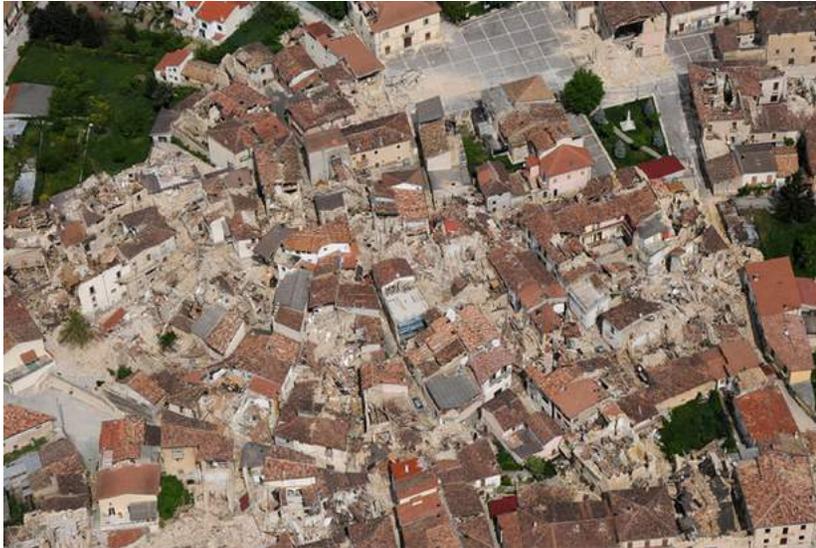
Figure 1 – Villa Sant'Angelo, aerial view of the historic centre after the earthquake

In Fossa, the reduced number of residents in the historic centre has probably allowed the preservation of the integrity of the built environment that still characterizes the city centre and its surroundings. In Villa Sant'Angelo - where alterations due to recent interventions are widespread - a rebirth of the economy had begun just before the earthquake, related to the attraction of the historic centre and the quality of the surrounding environment and partly to seasonal tourism in nearby mountain districts (Figures 1-2).

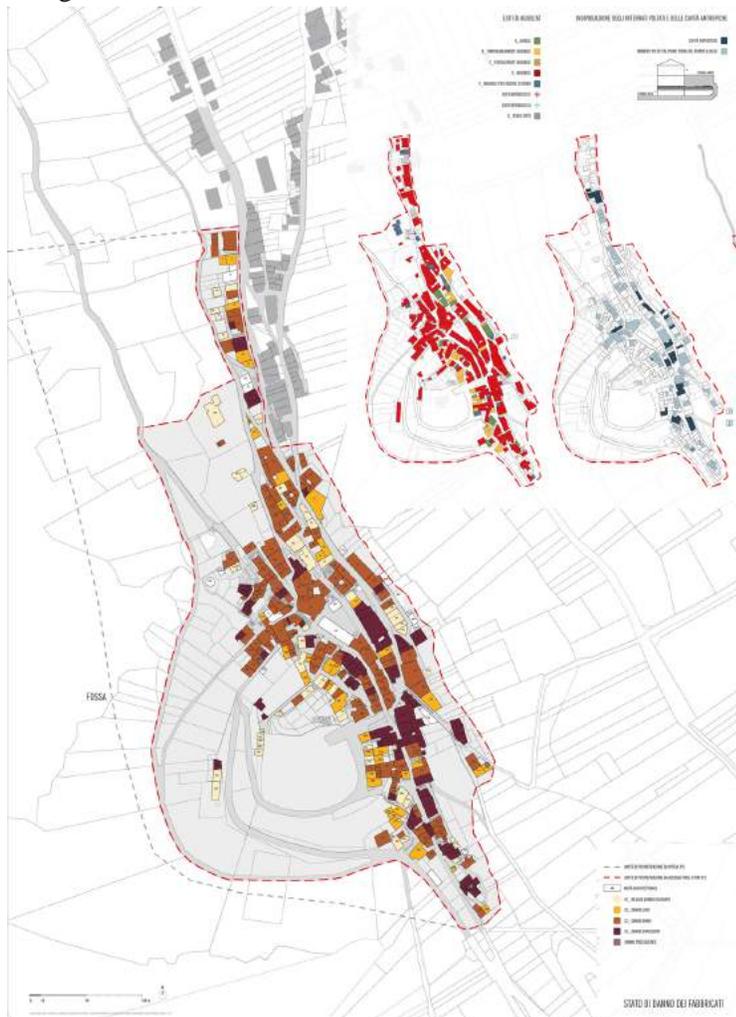
Figure 5 – Fossa, damage condition maps

Despite the fact that the historical centre in Fossa was affected less severely than in other neighbouring towns - probably due to compactness of the bedrock on which it is built and to the quality of the construction technique characterizing its buildings - the damage was spread to most of the urban fabric and a landslide originating from the side of Mount Circolo - overlooking the town - has made the whole historical centre inaccessible.

Unlike Villa Sant'Angelo, here collapses were sporadic and limited to few buildings, but the crack patterns and damage mechanisms activated by the action of the earthquake are widely scattered in the urban fabric and have led to a damage condition that necessarily requires coordinated and integrated action. That picture must be considered against the backdrop of the importance of the centre in terms of historical and environmental built heritage and architectural features with buildings of considerable importance (e.g. the fortified castle, the church and square of Santa Maria Assunta and the peripheral church of Santa Maria ad Cryptas) (Figures 5-6).

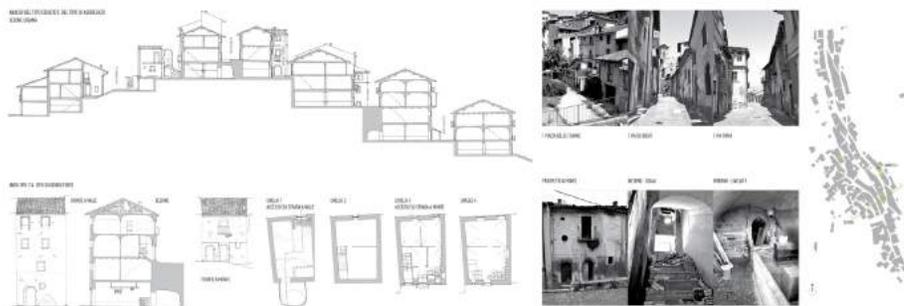
Figure 6 – Fossa, urban and architectural analyses

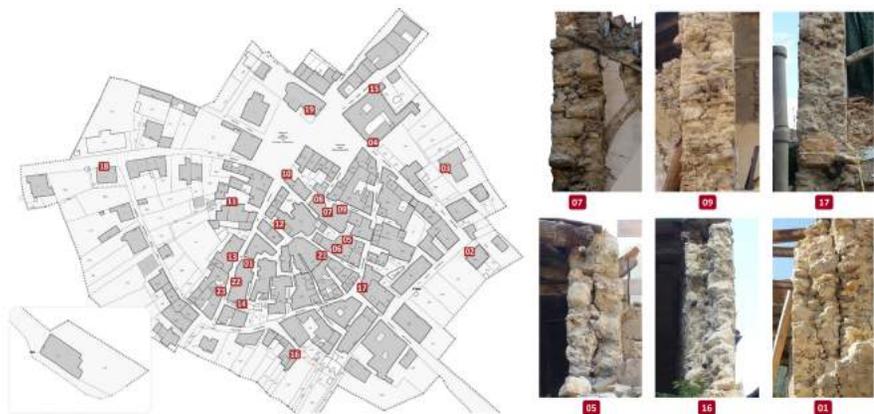
Figure 7 – Villa Sant'Angelo, masonry works analysis

The collected data about the buildings' use and location of the principal houses was also the subject of specific investigation, supported by information collected through the acquisition of statements by the owners. At the scale of the elements composing the building, the structural arrangement and groupings were observed, emphasizing positive features and weaknesses of local construction techniques (Figure 7).

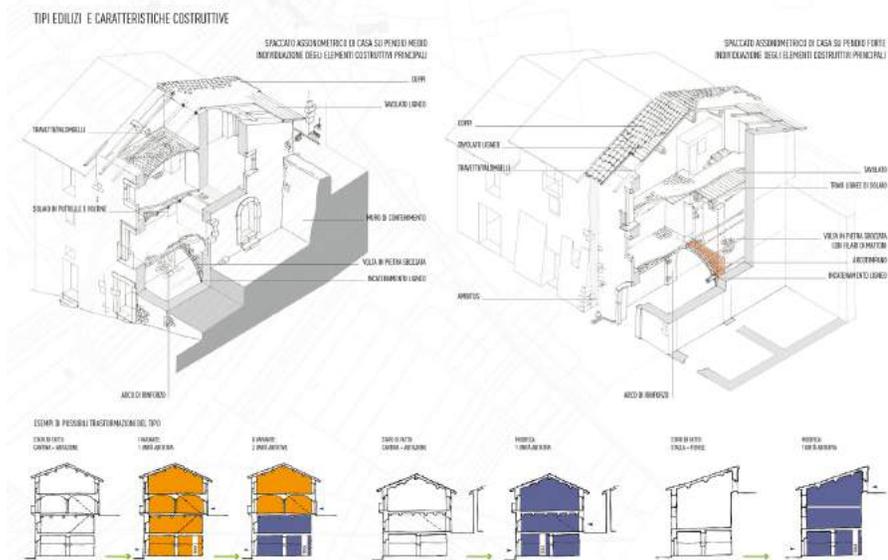
Figure 8 – Fossa, building types and buildings' construction analysis

In the case of Fossa, a systematic analysis of the local construction lexicon has allowed the identification of phases of evolution of the centre and its seismic history through examination and mapping of anti-seismic devices and pre-modern repair interventions (spurs, scarp walls, chains and hoops) (Figure 8).

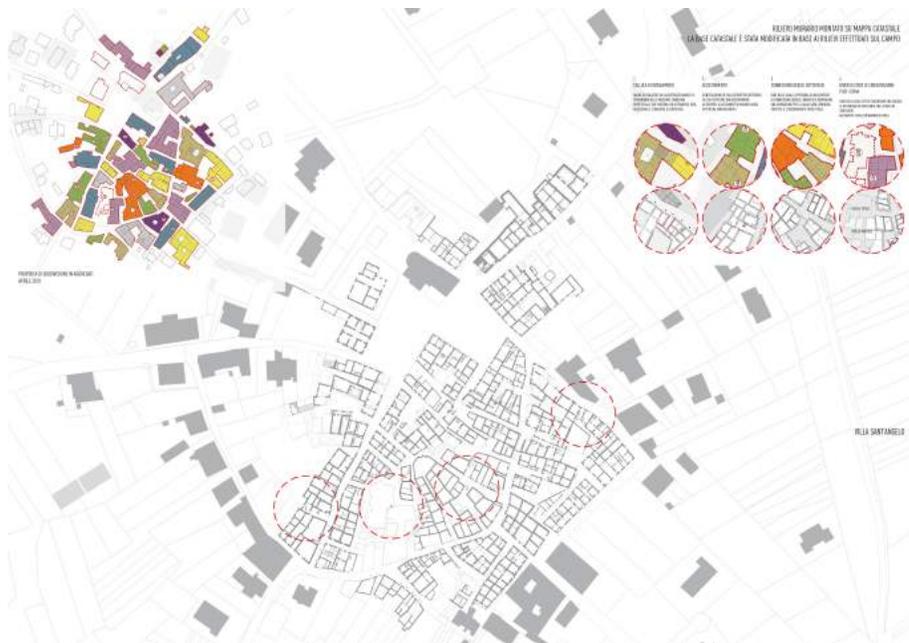
Figure 9 – Villa Sant'Angelo, aggregates' identification and definition criteria

First is the division of the urban fabric into sub-areas (this is a procedure explicitly required by the law) derived specifically from the actual state of the built-up area as interpreted following the comparison between information collected at different scales of analysis (from urban analyses, to those concerning blocks' layout, construction techniques and damage) (Figure 9).

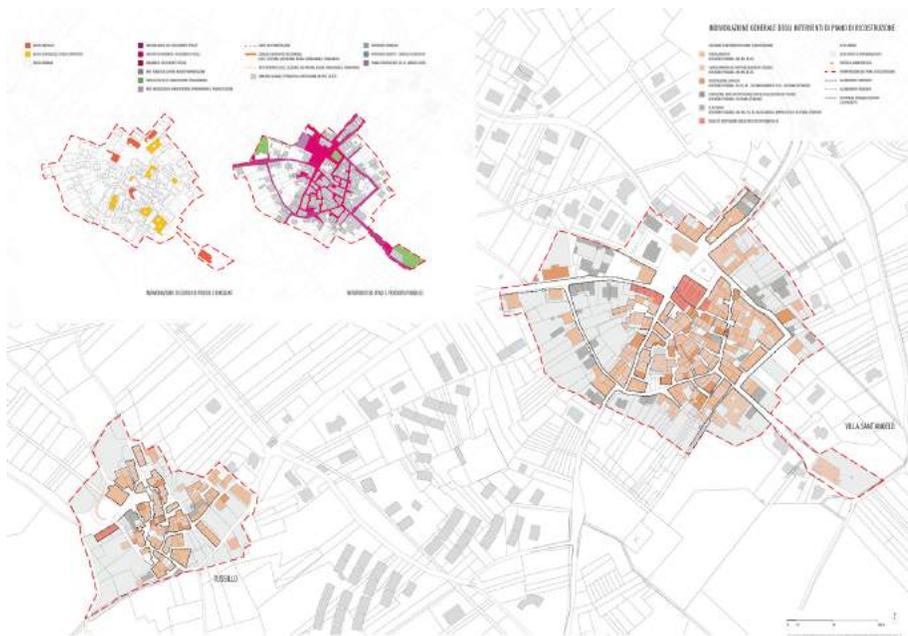
Figure 10 – Villa Sant'Angelo, urban plan

This criterion has been observed in relation to damage conditions and the possibility to identify surviving built-up portions that will be preserved and will provide a starting point for the reconstruction and consolidation of the urban fabric (Carocci et Al. 2012) (Figure 10).
